Chemung County Stormwater
Construction Inspection
Erosion and Sediment Control

PROJECT: Hickory View Apartments
Town of Big Flats
Municipal Inspection
February 25, 2013

BY Jessica Verrigni, CPESC, CPSWQ

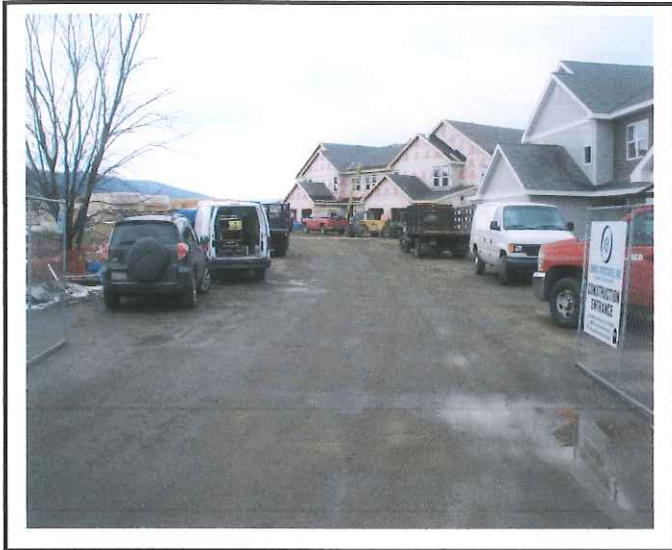
Sediment is accumulating on blacktop. This needs to be swept before it becomes a tracking issue during spring melt.

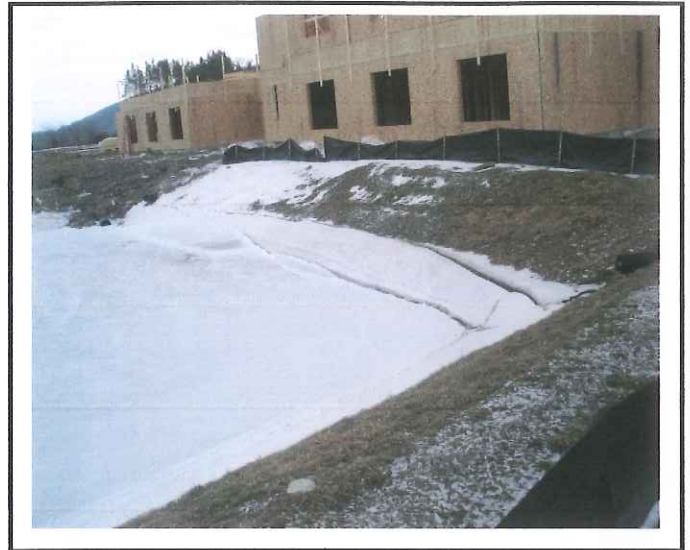
Silt fence is down around portions of the center pond. The level of the pond has dropped significantly since overflow pond was constructed.

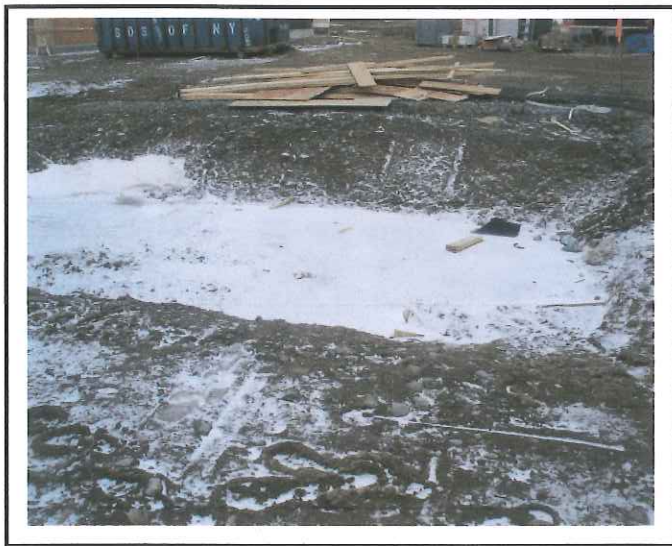
New basin next to building 4 has litter and construction debris in it.

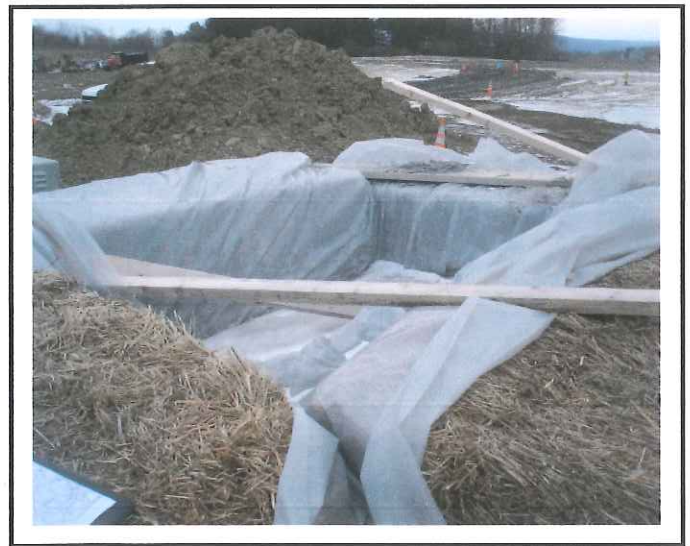
Concrete washout is on-site and functioning.

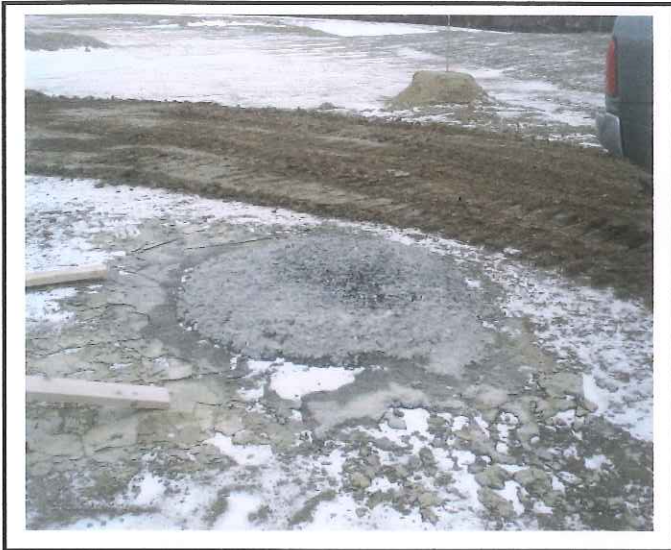
Concrete was washed out onto the ground directly next to concrete washout area.

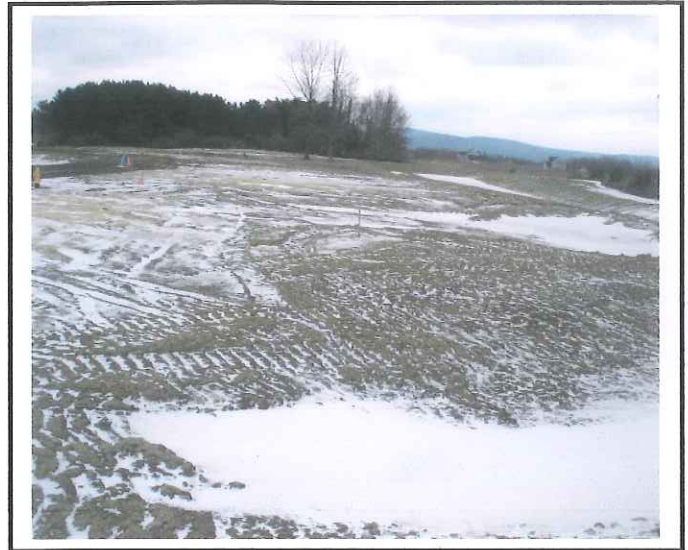
All areas at the back of the property are graded and remain unstabilized.

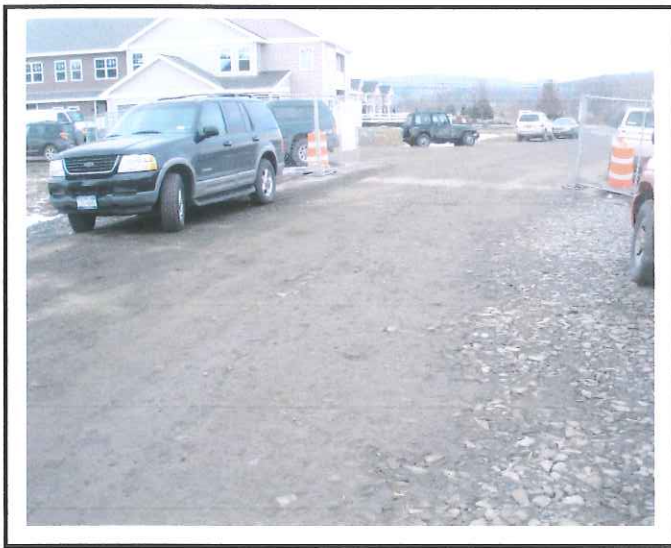
Construction entrance is in need of maintenance.

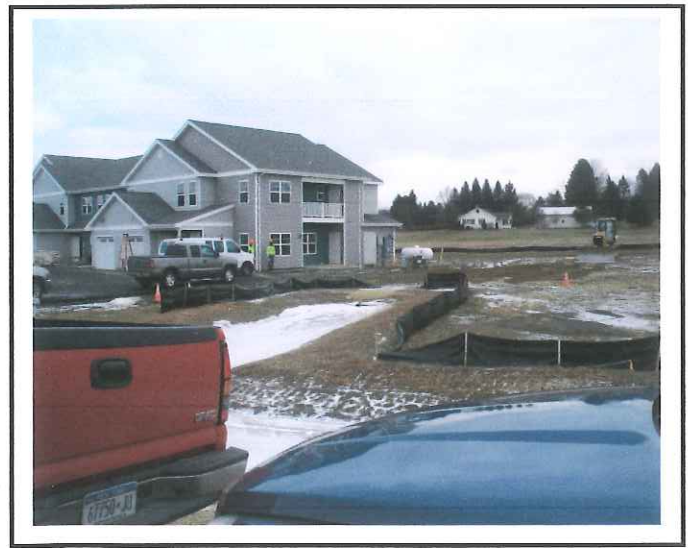
Many areas around the property silt fence needs maintenance.
