Chemung County Stormwater  
Construction Inspection  
Erosion and Sediment Control

Project Name	Parmenter Tire	Date	6-16-14
Location	Horseheads Industrial Park	Permit #	NYR10X355
Weather Conditions	Sunny - warm	Entry Time:	10:57
On-Site Representative Present:		Exit Time:

<b>PROJECT:</b>	Parmenter
	Village of Horseheads
	Municipal Inspection
	June 16, 2014
<b>BY</b>	Jessica Verrigni, CPESC, CPSWQ

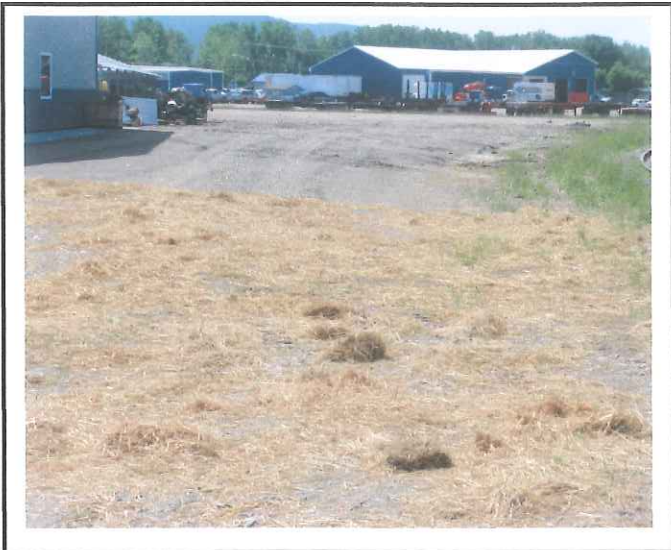
Area seeded and mulched.

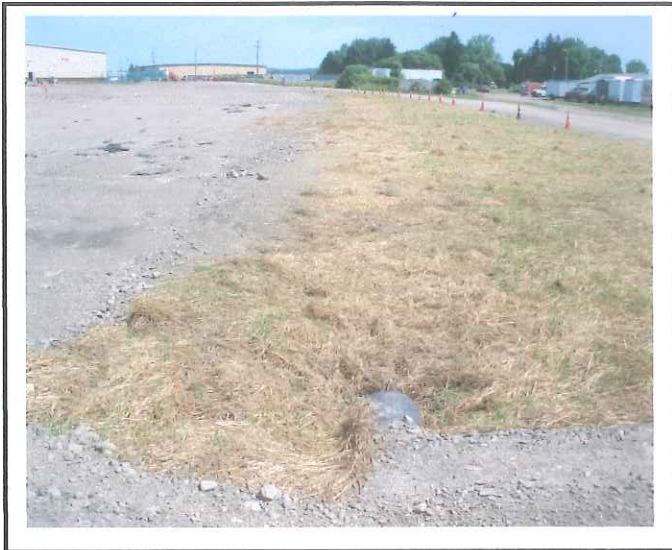
Area seeded and mulched.

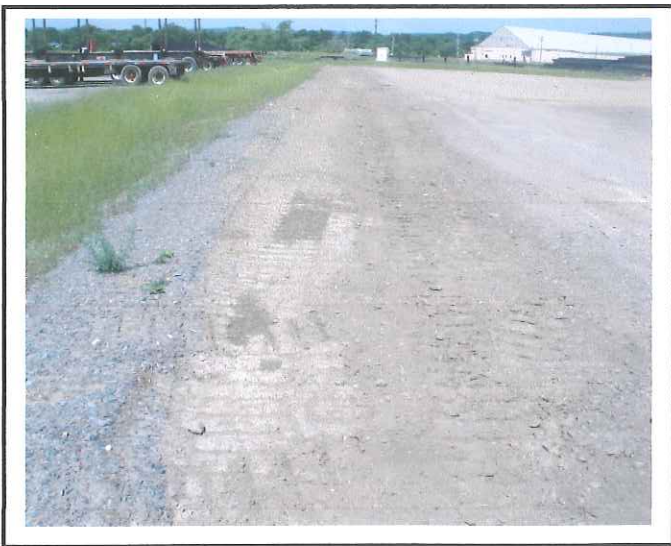
Rain Garden without mulch-6" depth is not achieved.

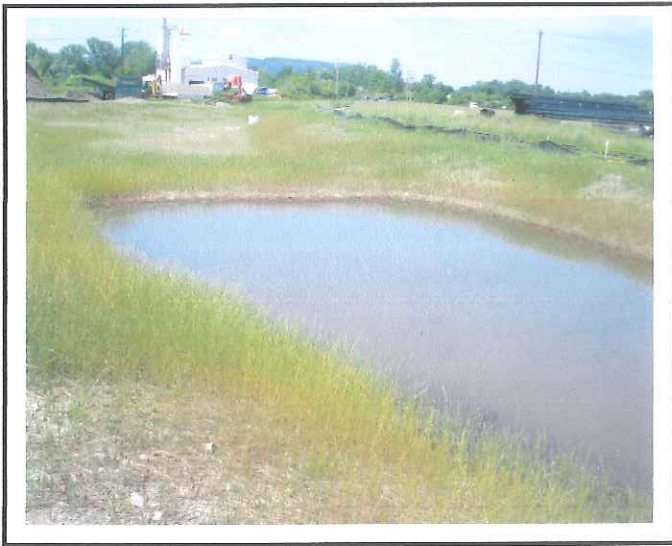
Stormwater forebay is holding water.

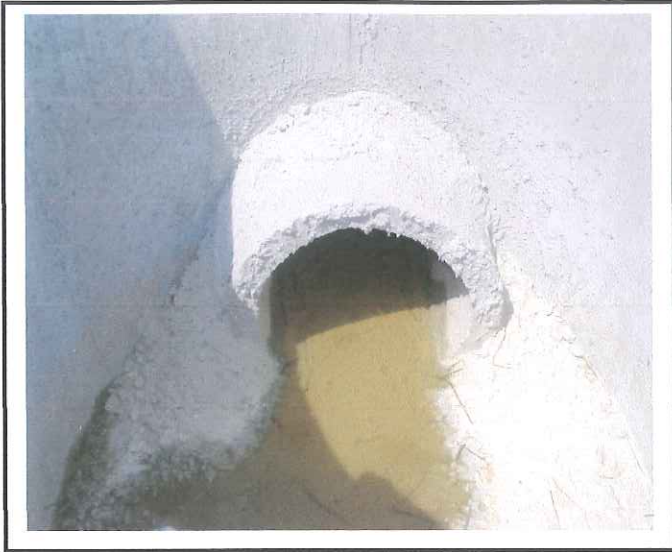
Outlet pipe has been grouted.

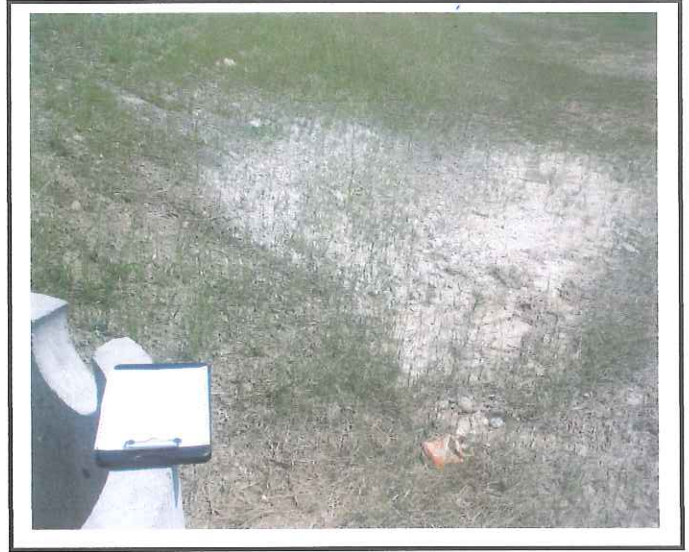
Concrete was washed out onto the side slope of the stormwater pond.

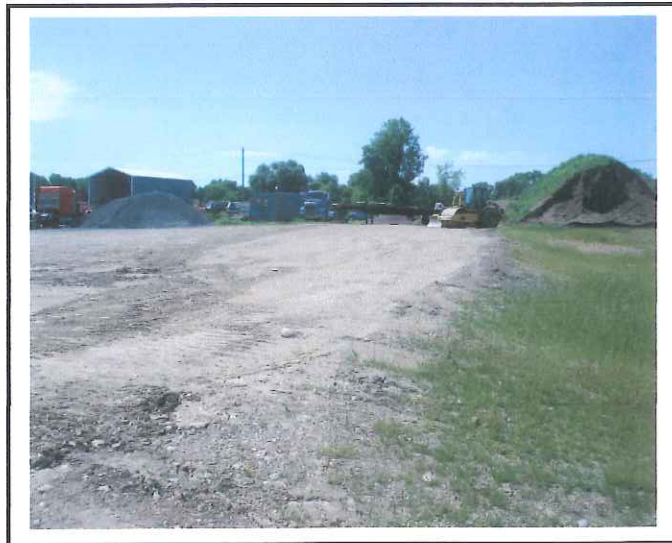
Looks like new fill material from separate facility has been added and drainage flows directly into pond.

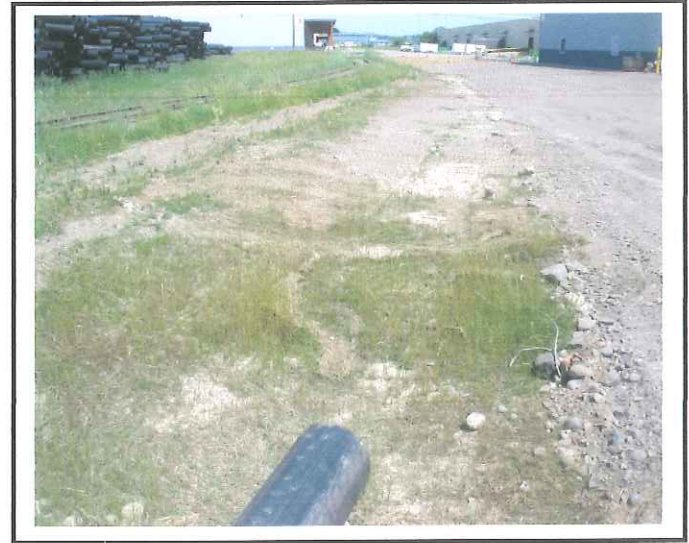
Swale is undefined and there is no rain garden installed.
