Chemung County Stormwater
Construction Inspection
Erosion and Sediment Control

Project Name <u>Red Robin</u>	Date <u>6/16/2014</u>
Location <u>So. Tier Crossing</u>	Permit # <u>NYR10J873</u>
Weather Conditions <u>sunny</u>	Entry Time: <u>9:00</u>
On-Site Representative Present: <u>Raymond Miles</u>	Exit Time: <u>9:20</u>

PROJECT:	Red Robin
	Town of Horseheads
	Municipal Inspection
	June 16, 2014

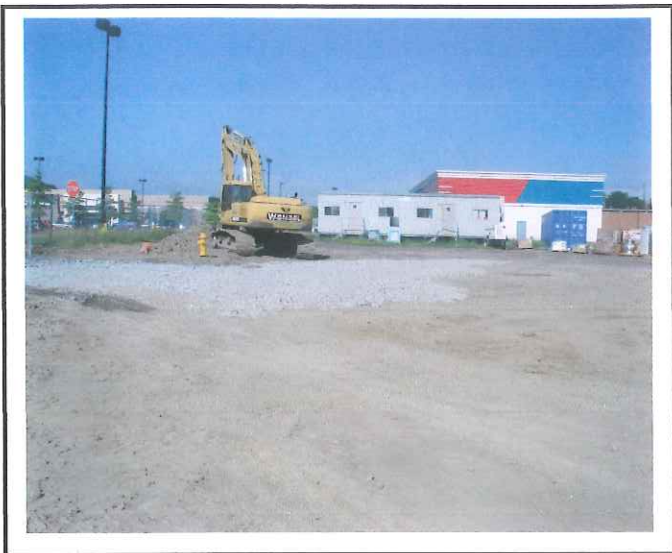
- Construction entrance has been re-topped - looks good

Construction entrance was recently re-topped with fresh stone.

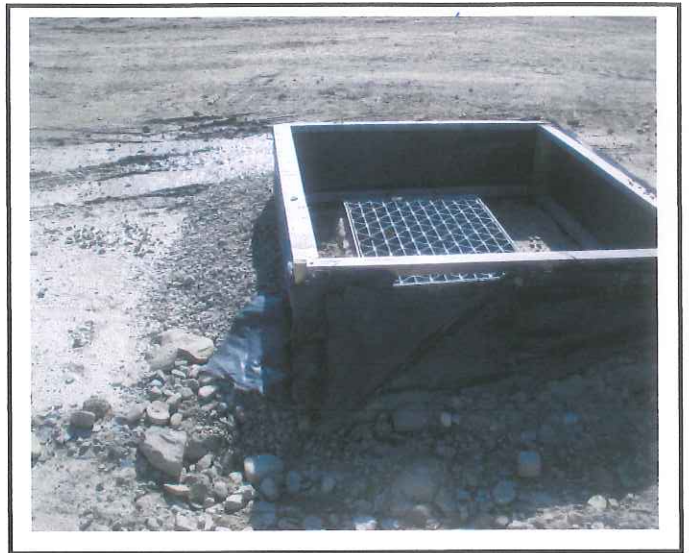
#1 - ^{Both} Drop inlet protection - ~~at~~ ~~entrance~~ requires maintenance - replace fabric - there are holes

Drop inlet protection has holes and needs to be replaced.

Repair drop inlet protection. Site looks good

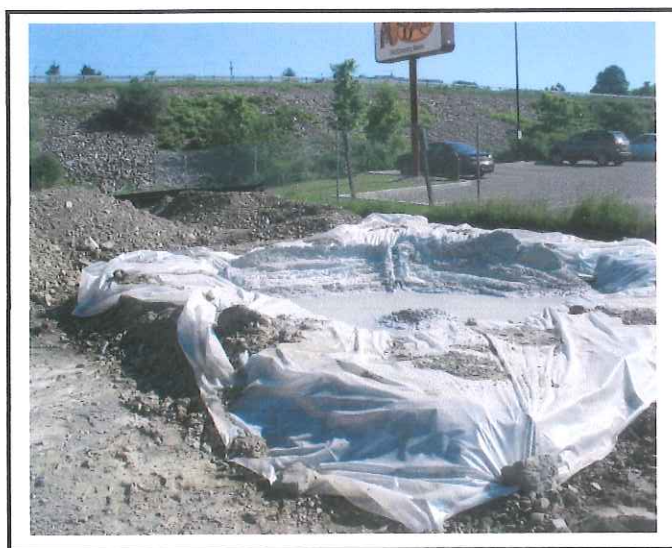
Note - concrete washout is near capacity

Concrete washout is near capacity and needs maintenance soon.

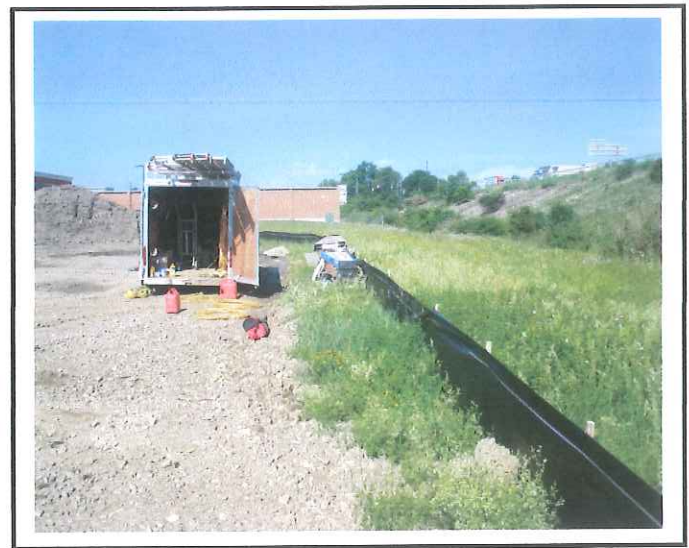
Silt fence maintained between project and stormwater swale.
