Chemung County Stormwater  
Construction Inspection  
Erosion and Sediment Control

Project Name: Hickory View	Date: 7/30/12
Location: <del>Hickory</del> Hickory Grove Rd Big Flats	Permit #: NYR10V597
Weather Conditions: mostly cloudy	Entry Time: 1:45p
On Site Representative Present: no one on site inc	Exit Time: 2:13
Sketch of Project site Include Disturbed Areas: last insp. 7/2/12 Satisfactory

<b>PROJECT:</b>	Hickory View Apartments
	Big Flats (T)
	Municipal Inspection
	July 30, 2012
<b>BY</b>	Jessica Verrigni, CPESC, CPSWQ

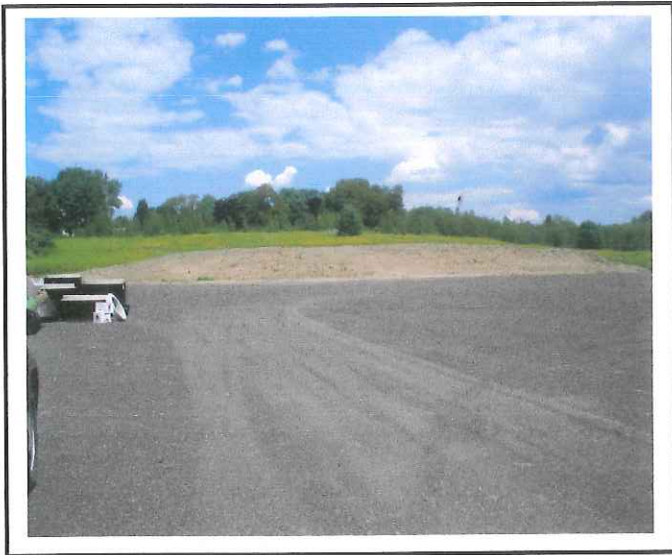
Contractor staging yard and stockpile area- the stockpile has been hydroseeded.

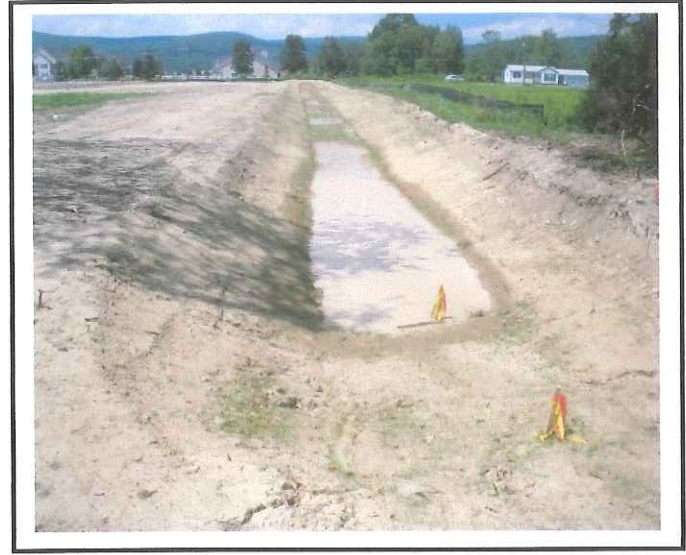
\* No rain since 7/27 and basins are still holding water

Infiltration trench BCD is still holding water.

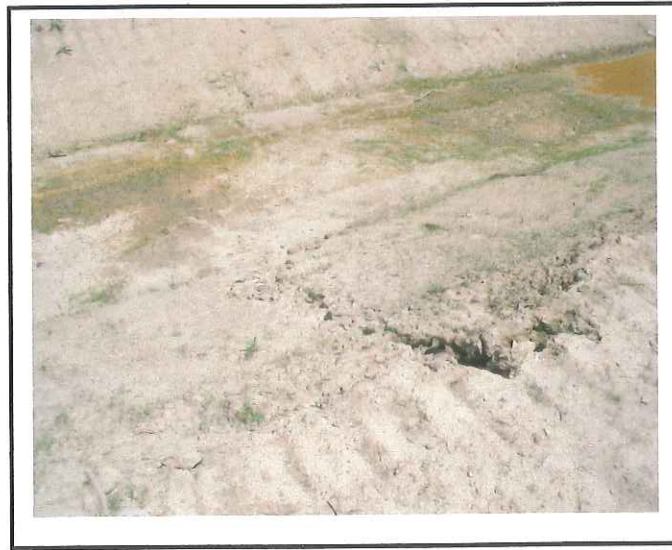
Erosion started on the side slope of infiltration BCD.

- Monitor the two infiltration areas to the Northeast of property - erosion has started.

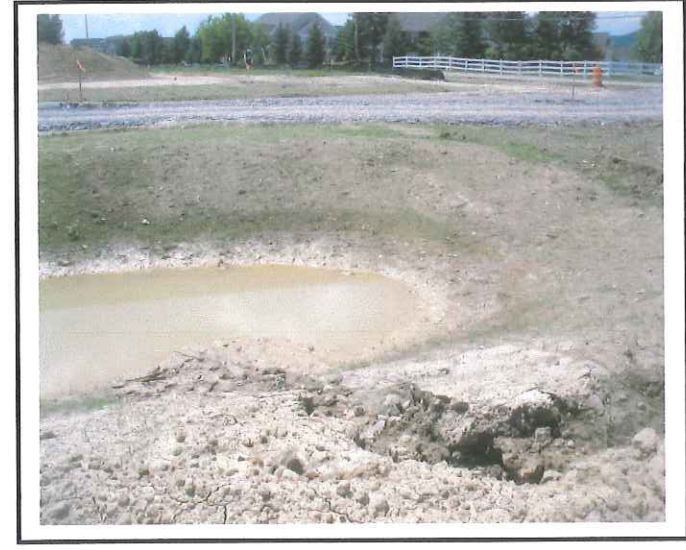
Infiltration trench A- major erosion has started on the side slope.

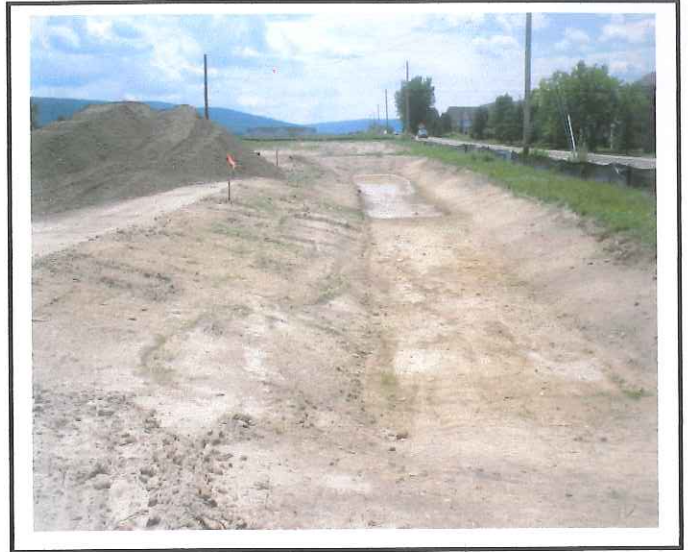
- Stockpile next to Hickory Grove is falling into the infiltration basin

Infiltration trench F2. Soil stockpile is too close to the edge of the basin (spoke with Dave of Wenzel).

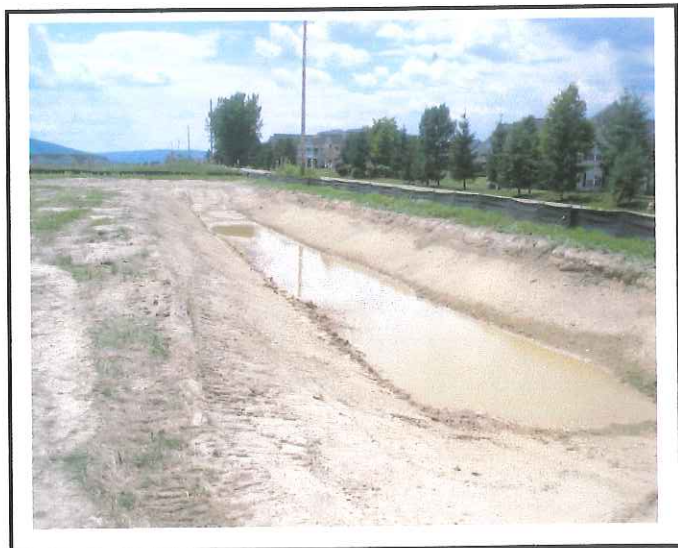
Infiltration F3- holding lots of water.

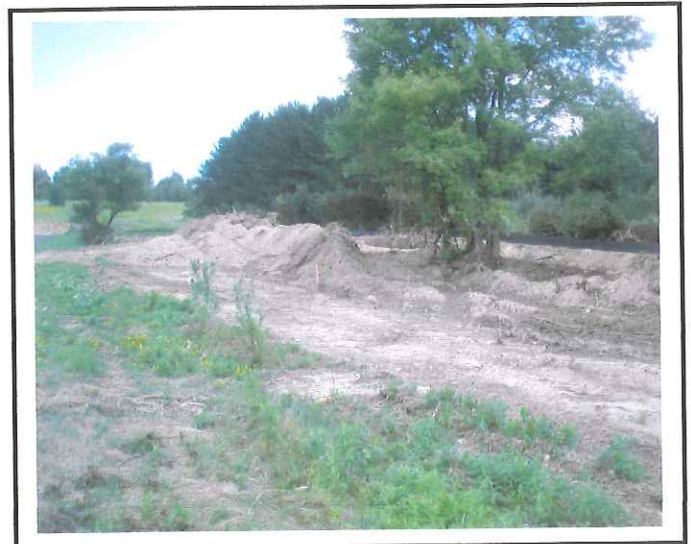
West side of construction area where active filling is occurring.
