Chemung County Stormwater
Construction Inspection
Erosion and Sediment Control

Project Name: Dollar General	Date: 8-14-15
Location: SR 14 Pine Valley (Town of Veteran)	Permit #: NYR10Y948
Weather Conditions: <i>Sunny</i>	Entry Time: <i>8:42</i>
On-Site Present: Jim Drogy 616-443-8713	Exit Time: <i>9:33</i>

PROJECT:	Dollar General
	Town of Veteran
	Municipal Construction Inspec.
	August 14, 2015

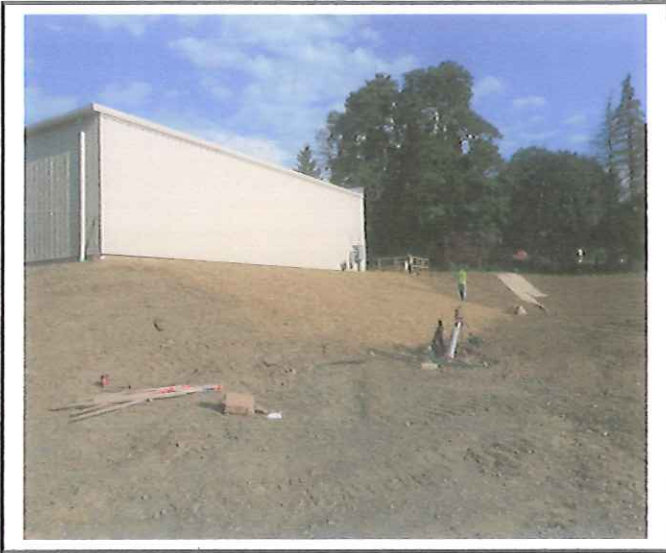
Slope behind building was being stabilized at time of inspection.

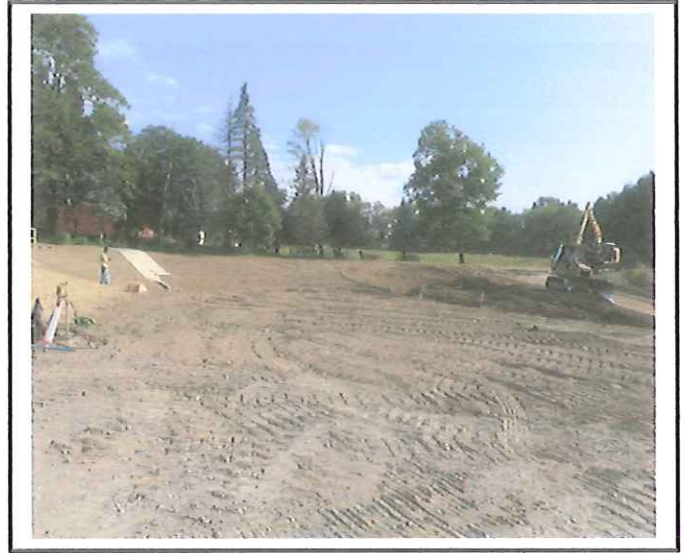
Topsoil being spread on side slope of infiltration basin.

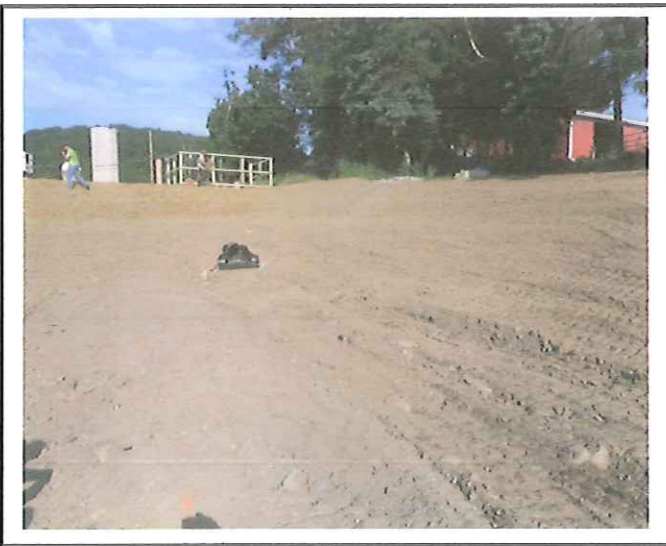
- last inspection on site dated June 17th 2014.
- forebay of infiltration basin is not lined with bentonite. Sediment marker not installed.
- observation well not installed.

Pipe discharging into forebay- outlet protection, rock lined swale and clay liner not installed.

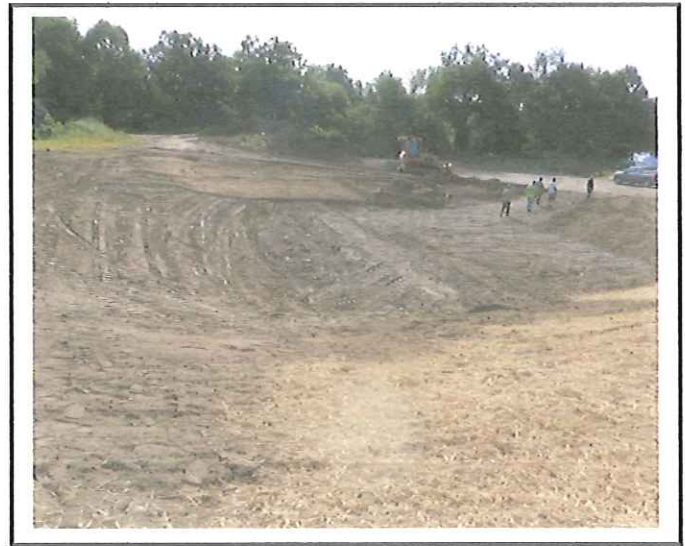
Scratched in infiltration basin.
