Chemung County Stormwater
Construction Inspection
Erosion and Sediment Control

Project Name	Hickory View Apartments	Date	12/14/12
Location	Hickory Grove Rd	Permit #	
Weather Conditions	sunny - cool	Entry Time:	2:09
On-Site Representative Present:	Elmira Structures	Exit Time:	2:38

PROJECT: Hickory View
Town of Big Flats
Municipal Inspection
December 14, 2012

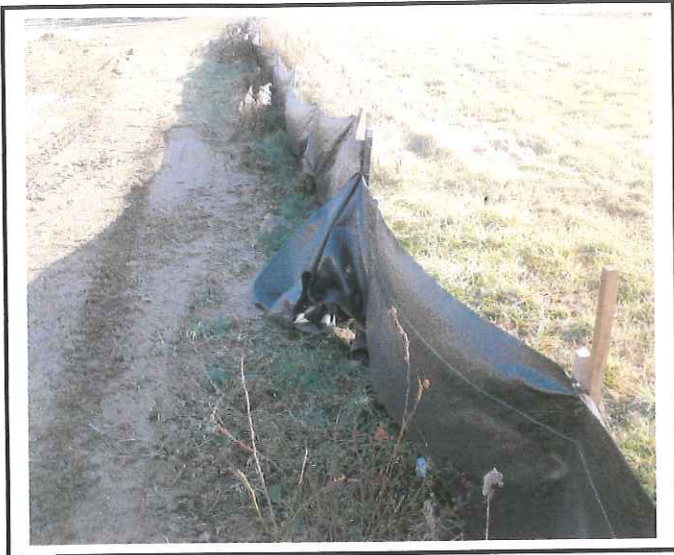
Silt fence needing repair.

Silt Fence repair needed next to Building 3, 2 corners of the pond, and next to Hickory Grove road between F2 + F3.

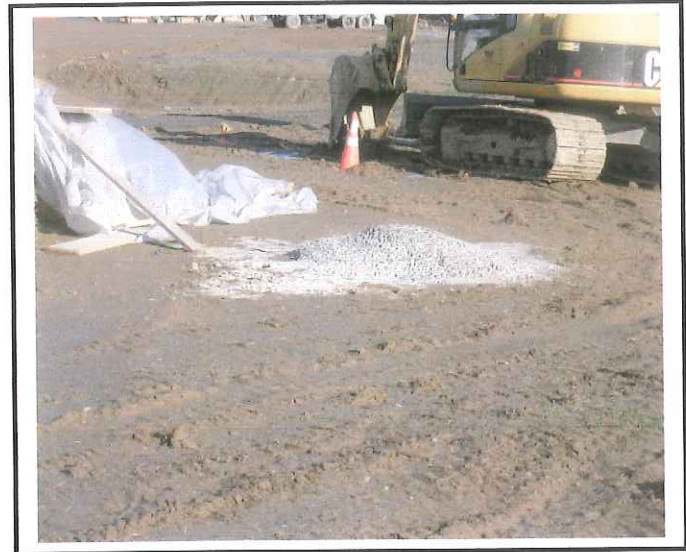
Concrete washout was full so someone washed out next to it.

Concrete Washout - Even though concrete is almost wrapped up - clean up concrete piles and remove old (full) washout areas.

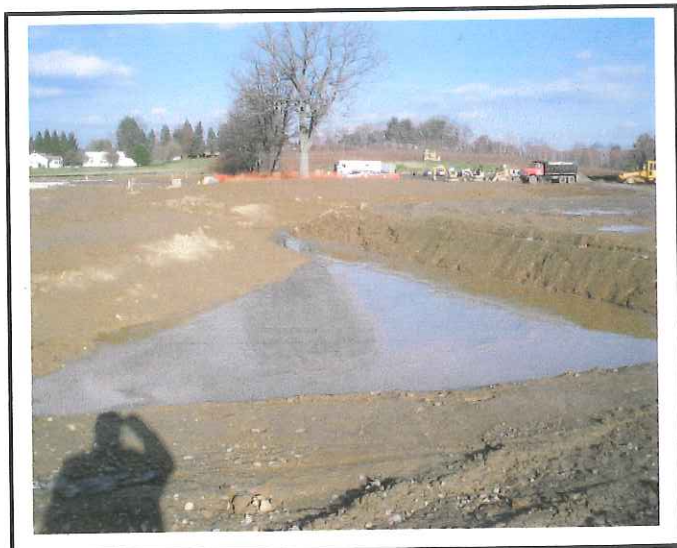
Infiltration K will need stabilization.

(B) Areas where infiltration K is needs stabilization

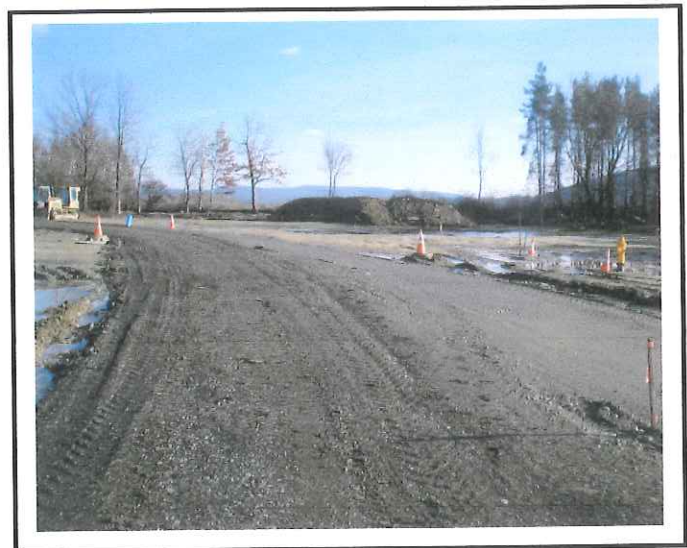
Stockpiles that are actively being built.

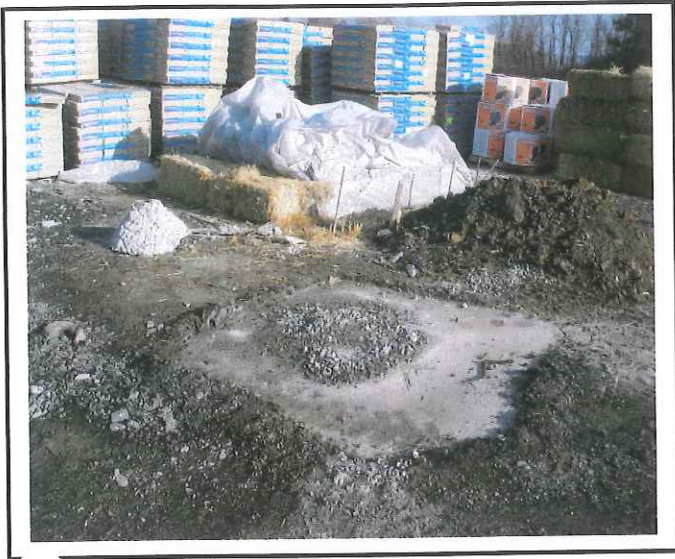
Concrete wash out in contractor yard was moved. A truck washed out next to the area that the washout was located.

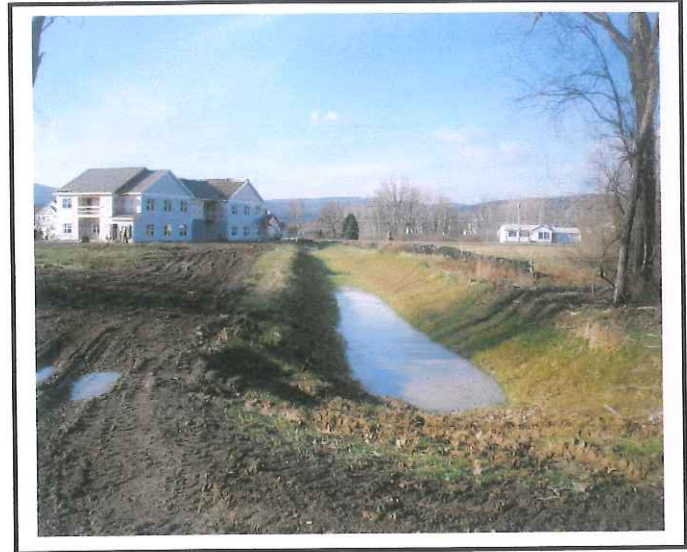
Infiltration trench BCD- Flat area was stabilized in November. But then it was utilized for building panel storage. Needs stabilization now that panels are up.
