Chemung County Stormwater
Construction Inspection
Erosion and Sediment Control

Project Name Biltmore Crossing Apartments	Date 5-1-15
Location Biltmore Drive Town of Horseheads	Permit # NYR10X559
Weather Conditions <i>Sunny</i>	Entry Time: <i>8:39</i>
On-Site Representative Present: no construction personnel on site	Exit Time: <i>9:15</i>

PROJECT:	Biltmore Apartments
	Town of Horseheads
	Municipal Inspection
	May 1, 2015
BY	Jessica Verrigni, CPESC, CPSWQ

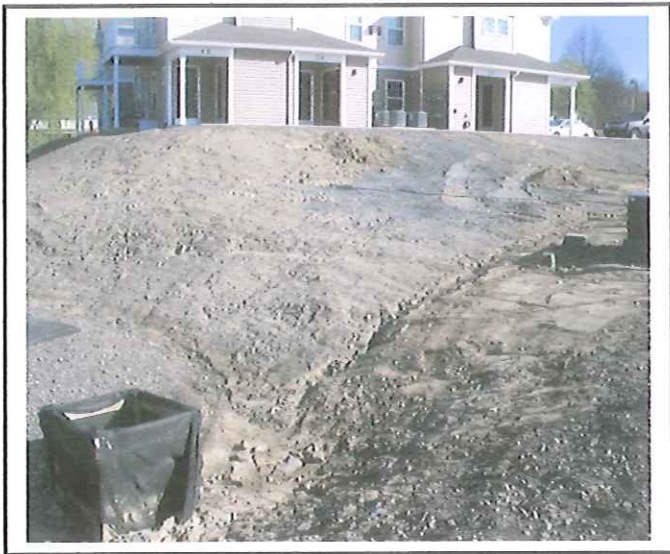
Swale in front of Building E is eroded and not stabilized.

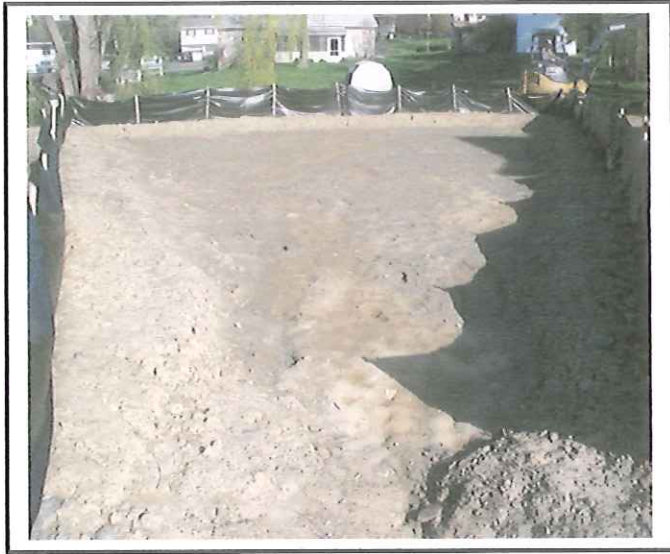
Rain Garden 1 is partially installed but sediment is getting into it. We will want to see the soil media prior to its installation.

-Rain garden 2 not installed. Reason garden 1 not complete. Our office will want to see soil media and some used during construction of these.

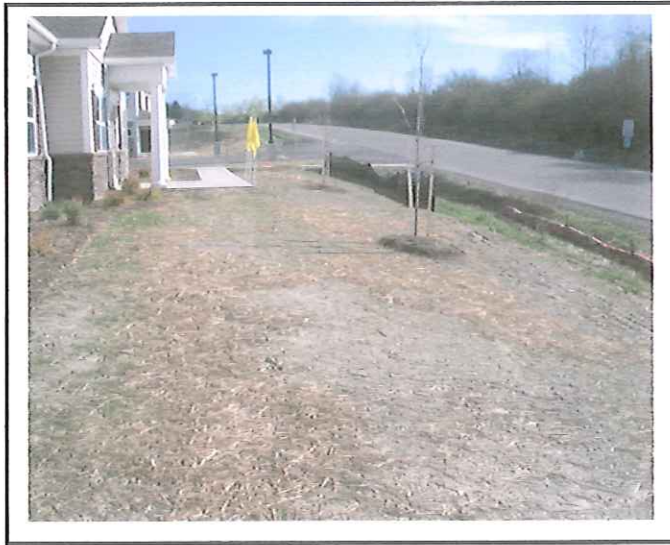
Areas around the Community Building and building C are not growing grass. These areas do not look like they will be suitable for growth-re-grading is necessary.

-soil around building d and c is compacted and not growing grass. This requires repairs.

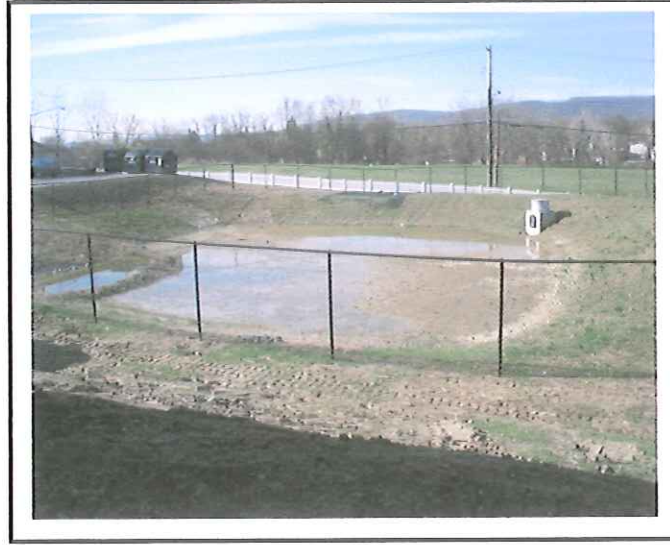
Pond will need to have sediment cleaned out of it prior to close out. Permanent stabilization is required. 1 foot berm pond and Building D has not been constructed.

-1' diversion berm between bldg. D and pond is not installed.

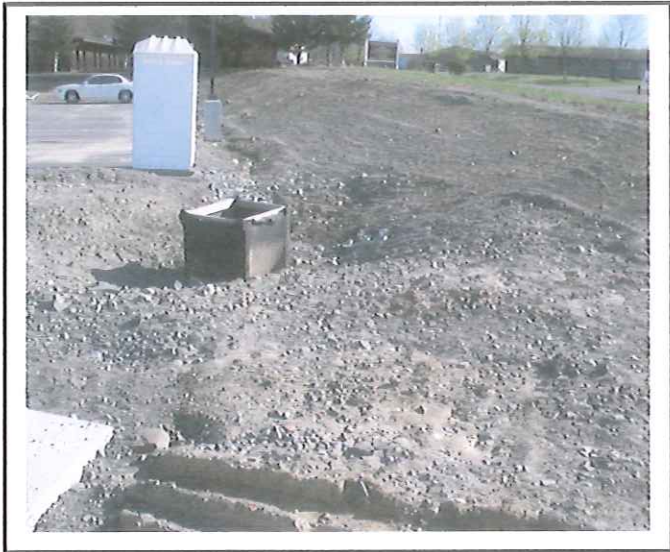
Erosion is occurring in the swale next to Biltmore drive and Building G. Light posts may be causing. Swale needs re-grading and stabilization.

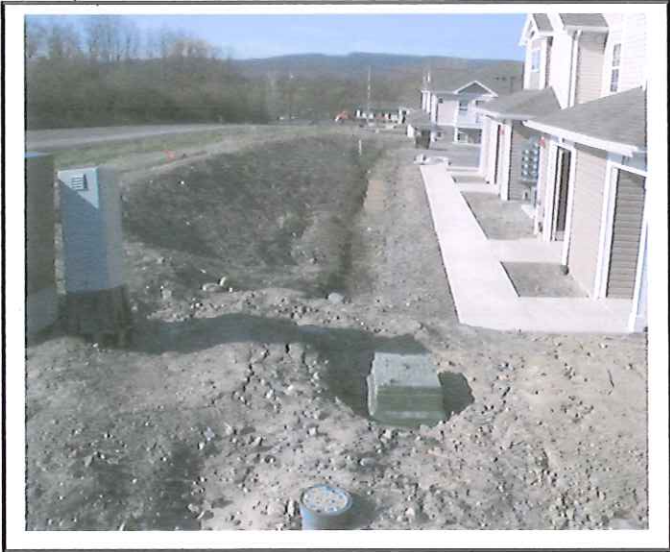
Many steep slopes around the buildings have yet to be topsoiled and stabilized.

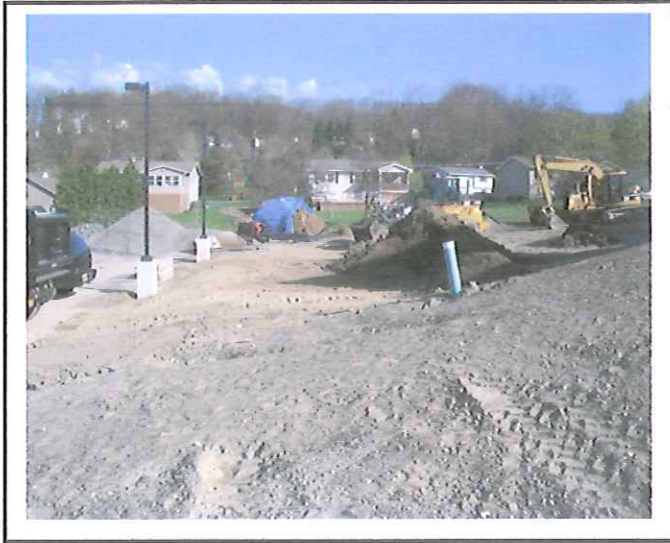
Rain Garden #2 has not been installed.

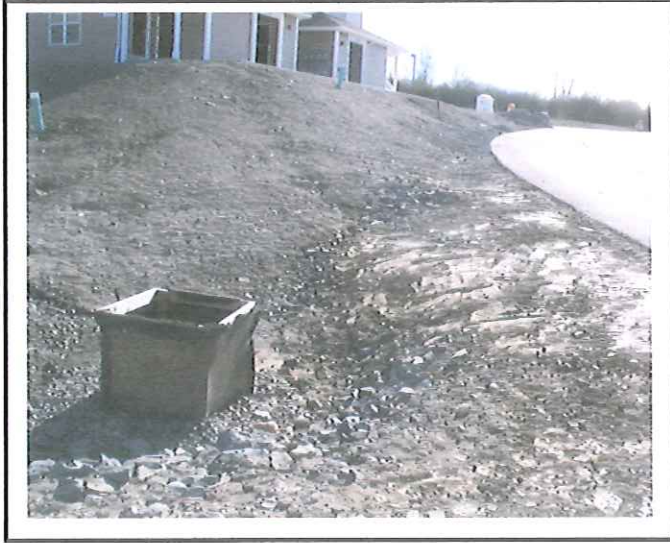
Swale in front of Building G has not been constructed.

-swale in front of building G is not installed.
