Chemung County Stormwater
Construction Inspection
Erosion and Sediment Control

| Project Name | | Hickory View Apartments | Date | | 12/4/14 |
| Location | | Hickory Grove Road Town of Big Flats | Permit # | | NYR10V597 |

PROJECT: Hickory View Apartments
Town of Big Flats
Municipal Inspection
December 4, 2014

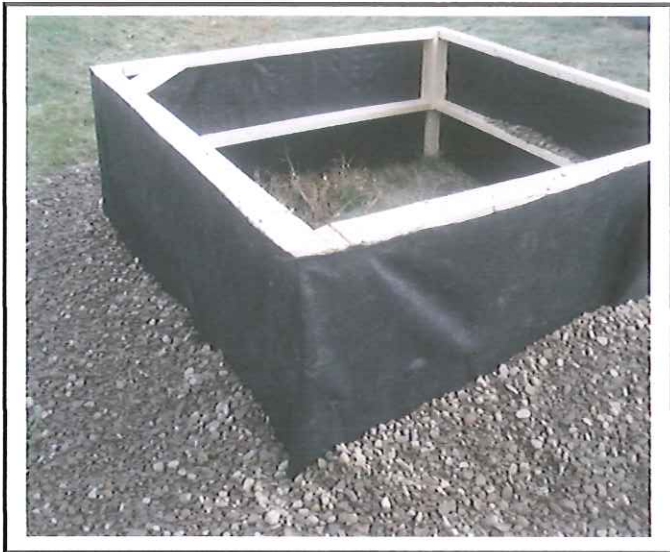
Material used for the construction of drop inlet looks to be impermeable. Monitor this to make sure water does not back up too much.

| -material use for drop inlet protection appears not to be permeable. I caution you to watch it to ensure that it does not become a problem. No correction is needed for this just monitoring. | | | | | |

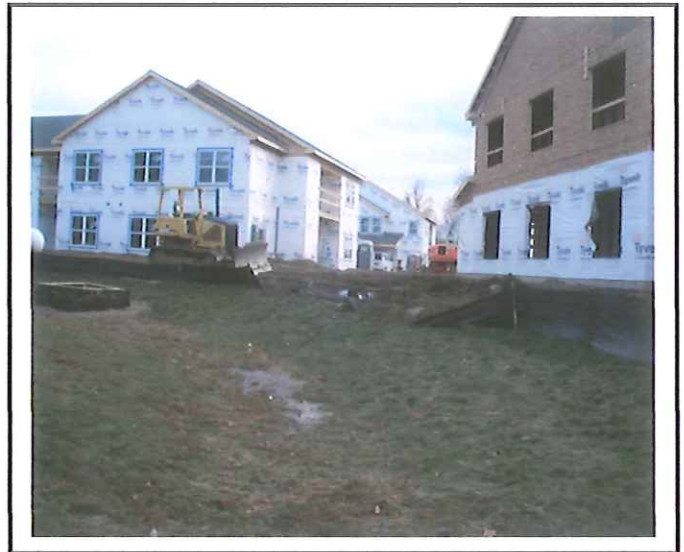
Silt fence needs to be maintained. Sediment can get into the swales and clog their infiltration.

| -sill fence around buildings is knocked down. This is allowing sediment into the vegetated swales which will need to be cleaned out prior to end of construction. | | | | | |

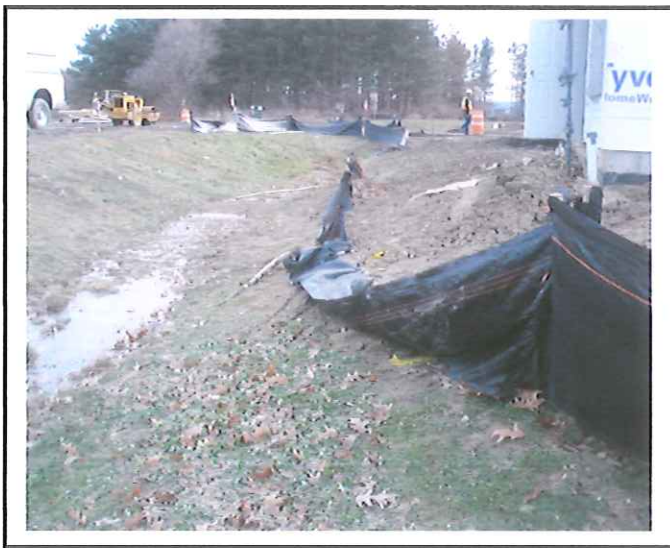
Silt fence needs to be maintained. Sediment can get into the swales and clog their infiltration.

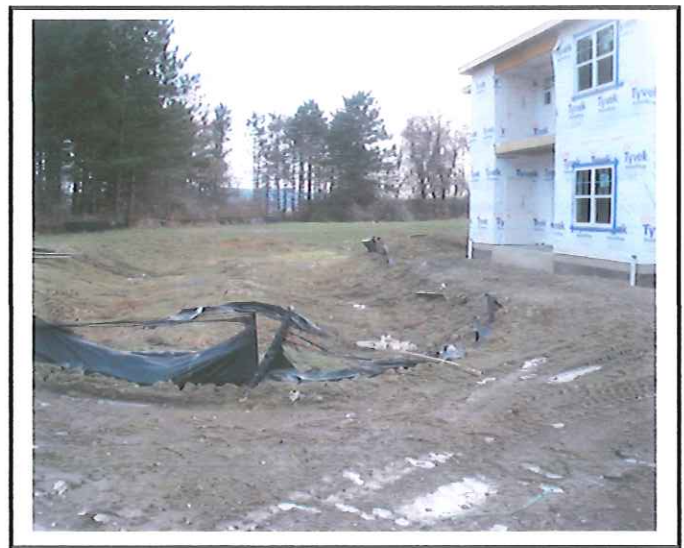
Silt fence needs to be maintained. Sediment can get into the swales and clog their infiltration.
