**Chemung County Stormwater
Construction Inspection
Erosion and Sediment Control**

Project Name Williams Toyota	Date 6-30-20
Location Fisherville Rd Big Flats, NY	Permit # NYR11F221
Weather Conditions overcast	Entry Time: 8:29 am
On-Site Representative Present: Willy Rowe	Exit Time: 8:52 am

PROJECT: Williams Toyota
Town of Big Flats
Municipal Inspection
June 30, 2020

BY: Jessica Verrigni, CPESC, CPSWQ

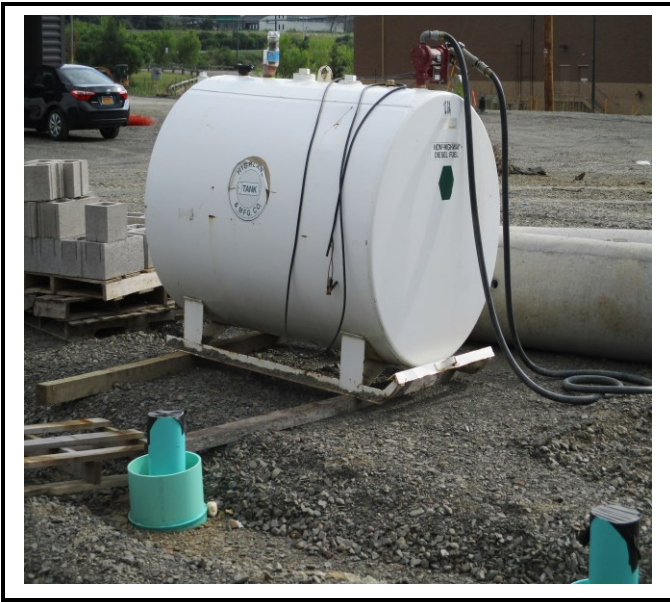
Diesel tank has been moved directly next to open observation ports of the underground infiltration system. Pollution prevention issue.

Corrections Needed:	
-Diesel tank has been relocated to the area directly next to the open observation ports of the underground infiltration system. Contractor not following pollution prevention guidance.	
-Catch basin protection not installed on water quality unit and catch basins tributary to the underground infiltration system on the north end of the property. Some catch basin protections still not installed correctly.

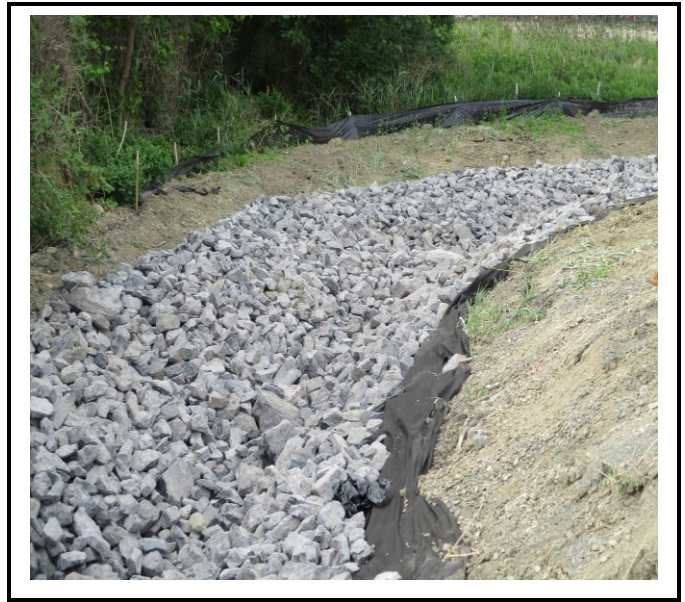
Rock lined swale being installed at time of inspection.

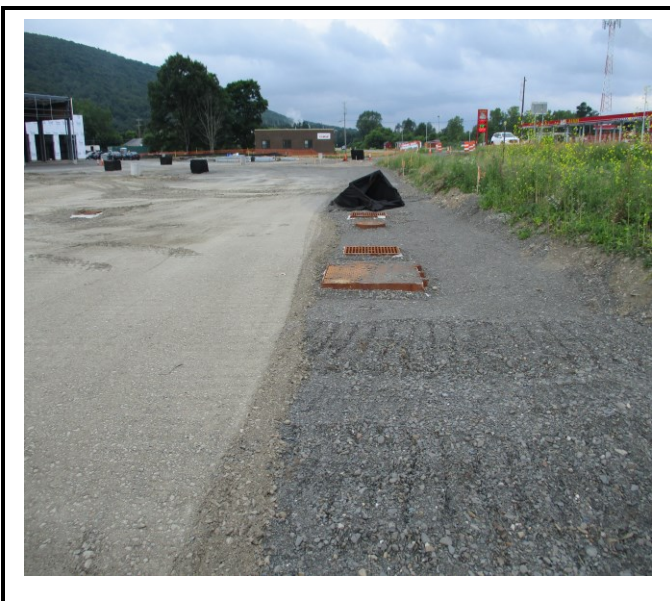
Catch basin and water quality unit that are direct tributary to underground infiltration system are open and unprotected from runoff.

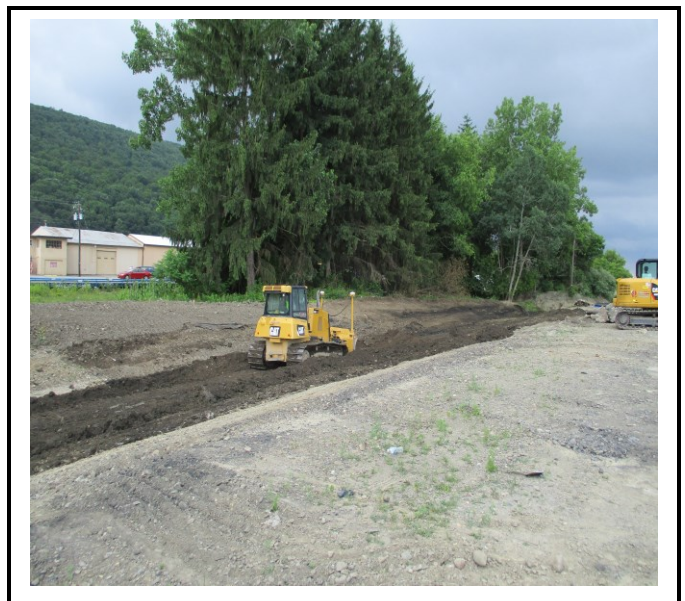
Grading of drainage swale occurring at time of inspection.
