Chemung County Stormwater  
Construction Inspection  
Erosion and Sediment Control

Project Name: Williams Honda	Date: 8/13/15
Location: CB 64 Big Flats	Permit #: NYR10
Weather Conditions: <i>Sunny</i>	Entry Time: <i>3:21</i>
On-Site Representative Present: Gene Beers	Exit Time: <i>3:45</i>

<b>PROJECT:</b>	Williams Honda
	Town of Big Flats
	Municipal Inspection

August 13, 2015

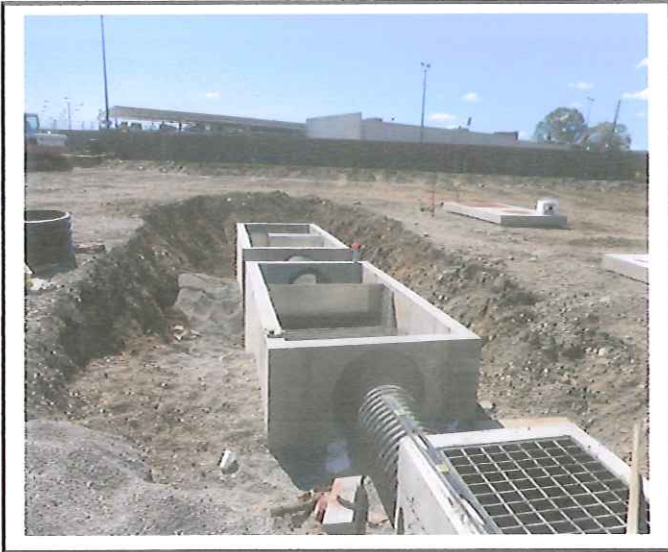
Water Quality Unit's 1 and 2

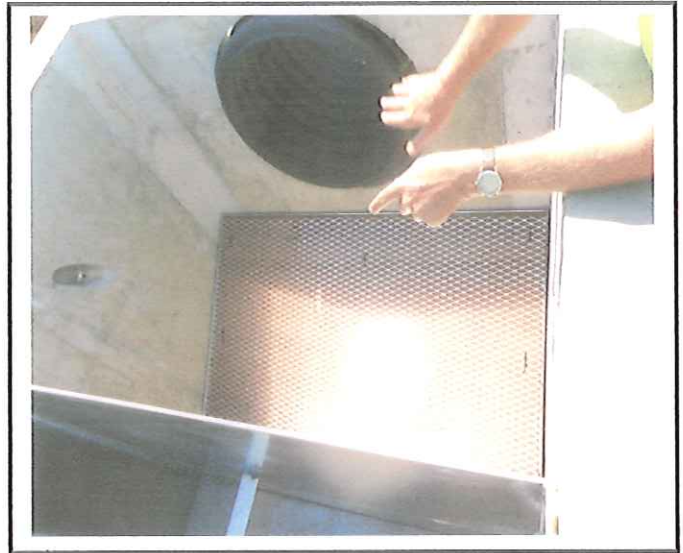
The inside of water quality unit 1 Coconut Fiber Screen

-contractor has some questions on the maintenance of these treatment tanks. the lid size doesn't match the coconut mat needing to come out of the tank.

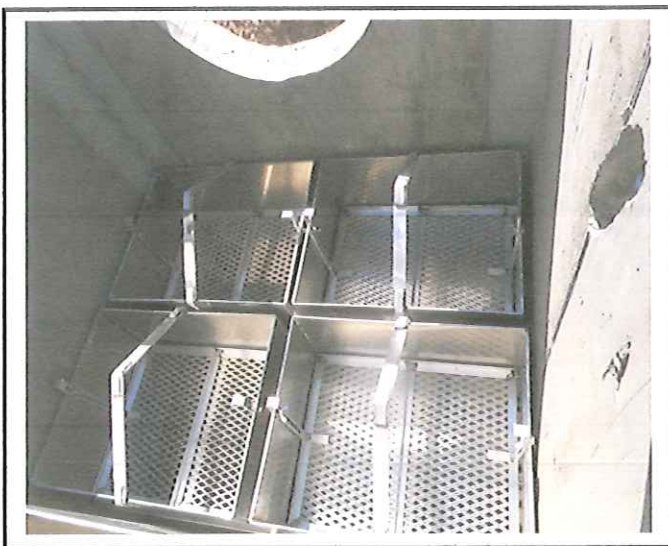
Water Quality Unit 2- The baskets do not have the filter media installed yet.

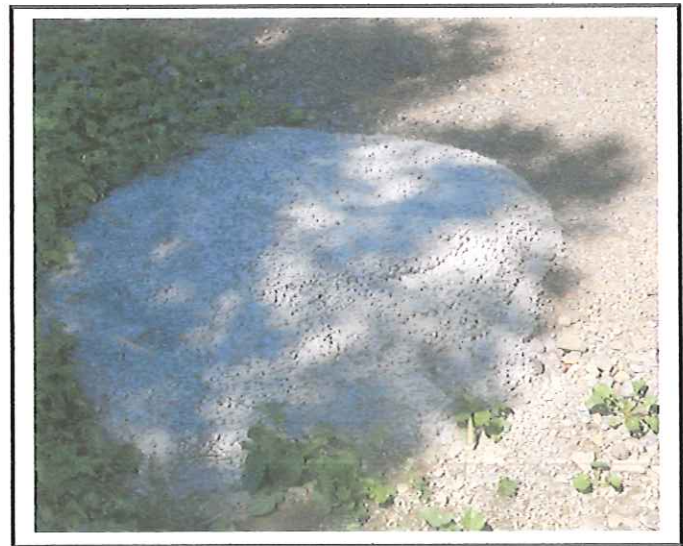
-concrete was washed out from the pumper truck onto the ground but the pile is small and all of the actual concrete hauling trucks did wash out in the concrete washout.

Concrete from the pumper truck was washed onto the ground. All delivery trucks did utilize the concrete washout area.
