**Chemung County Stormwater
Construction Inspection
Erosion and Sediment Control**

Project Name Southern Tier Logistics	Date 9-23-2022
Location HOST Facility, Horseheads (V)	Permit # NYR11J885
Weather Conditions sunny, cold, windy	Entry Time: 2:32 pm
On-Site Representative Present: none	Exit Time: 3:13 pm

PROJECT:	So. Tier Logistics Village of Horseheads MS4 Construction Insp. September 23, 2022
BY:	Jessica Verrigni, CPESC, CPSWQ

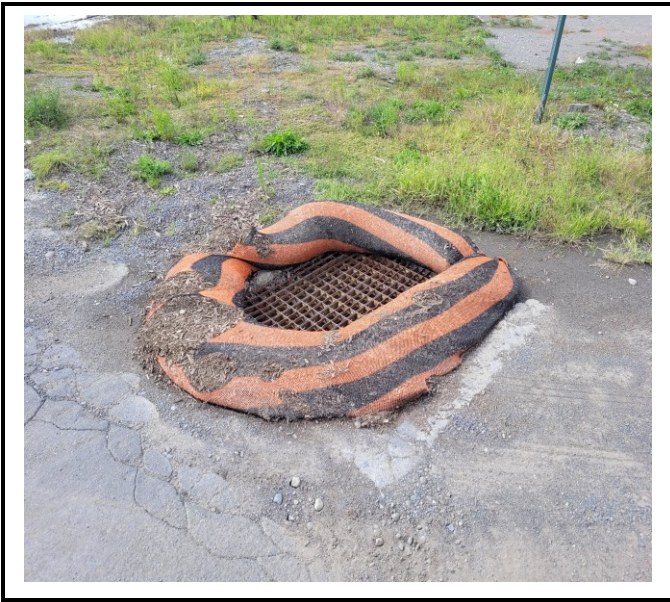
Compost sock inlet protection at most south end of building requires replacement

Corrections Needed:			
Inlet Protection- at the south end of the building there is an inlet protection that requires replacement.			
- Around the entire project site, any inlet protection runover that is no longer functioning because it is flattened, requires replacement.			
Topsoil Piles- Both on the concrete pad and at the south end of the project require stabilization if they aren't being utilized.			
Sediment Control- Piled materials on the concrete pad that have finer/course material require sediment control around them.

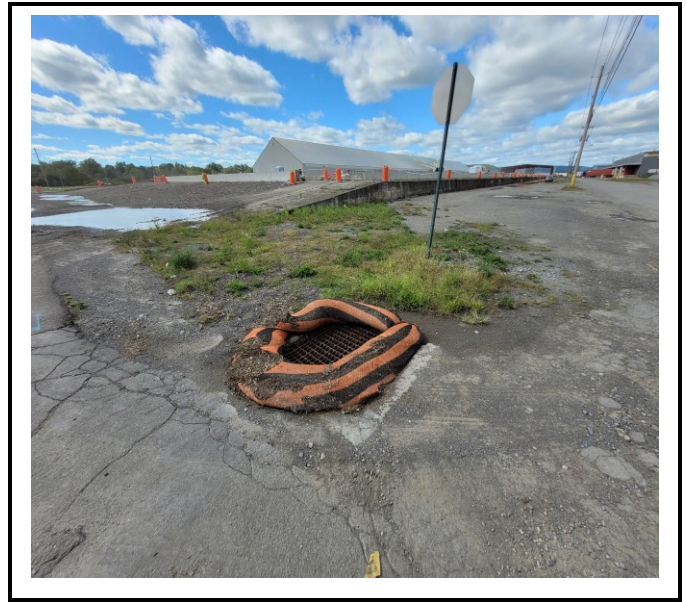
Compost sock inlet protection at most south end of building requires replacement

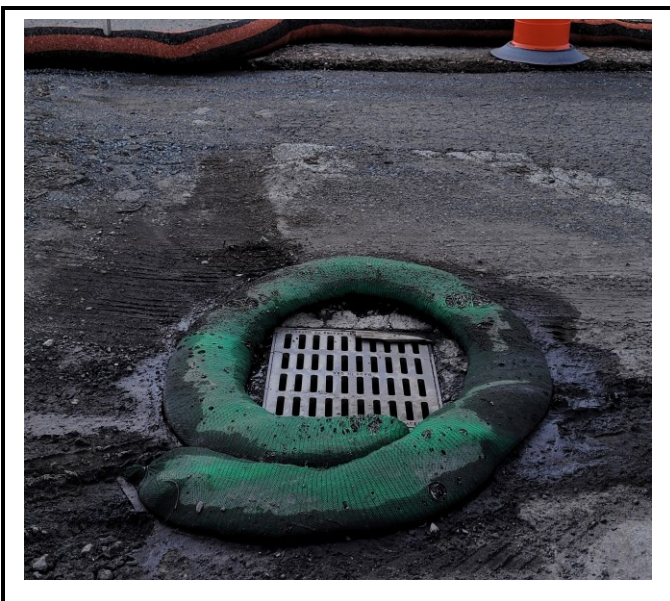
Inlet protection cannot be driven over. Anywhere that inlet protection has been flattened to the point of not providing protection requires replacement

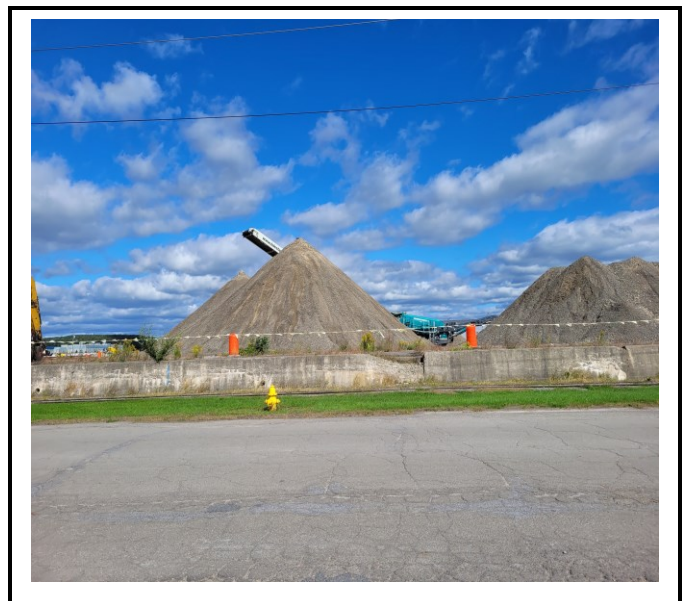
Stockpiles of finer materials do need sediment control around them.
