PROJECT:	Red Robin
	Town of Horseheads
	Municipal Inspection
	September 18, 2014

BY	Jessica Verrigni, CPESC, CPSWQ
-----------	--------------------------------

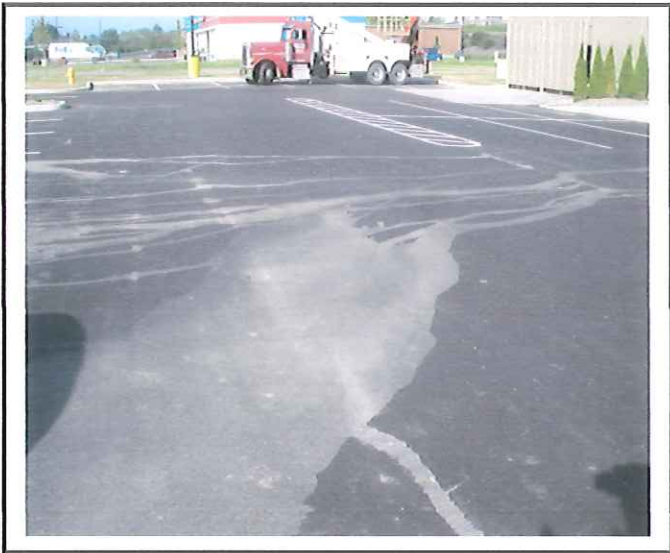
Sediment mixed with stormwater is flowing over concrete curbs into parking area. Soil does have hydro seed applied but minimal grass is growing.

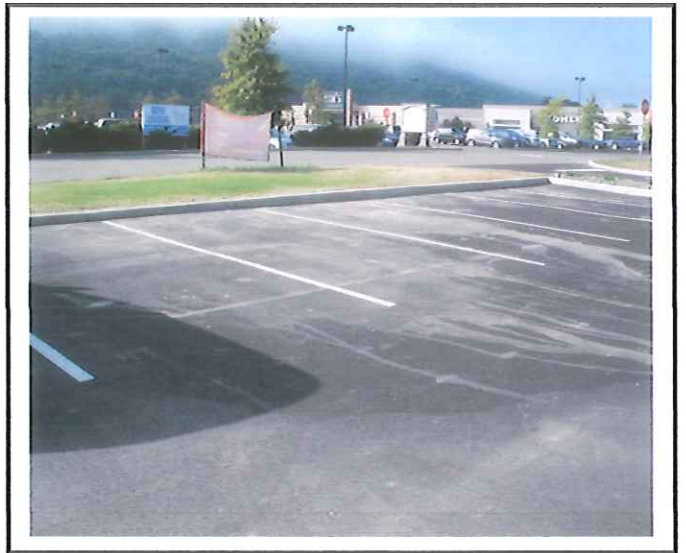
Sediment mixed with stormwater is flowing over concrete curbs into parking area. Soil does have hydro seed applied but minimal grass is growing.

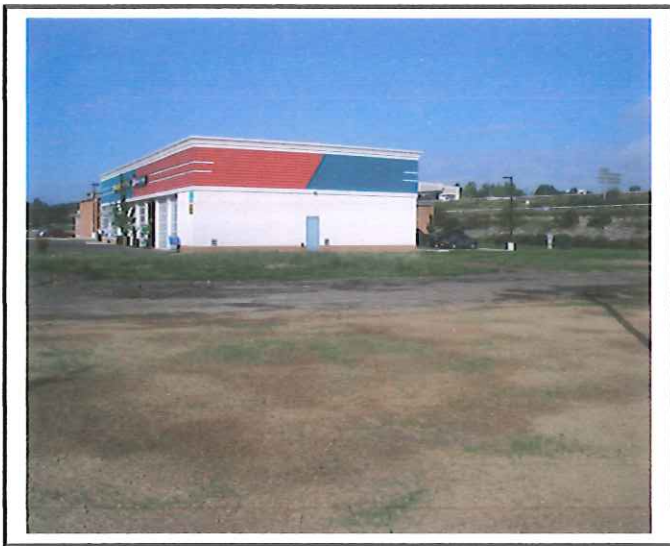
Area covered in milled asphalt that needs to be brought back to original condition.

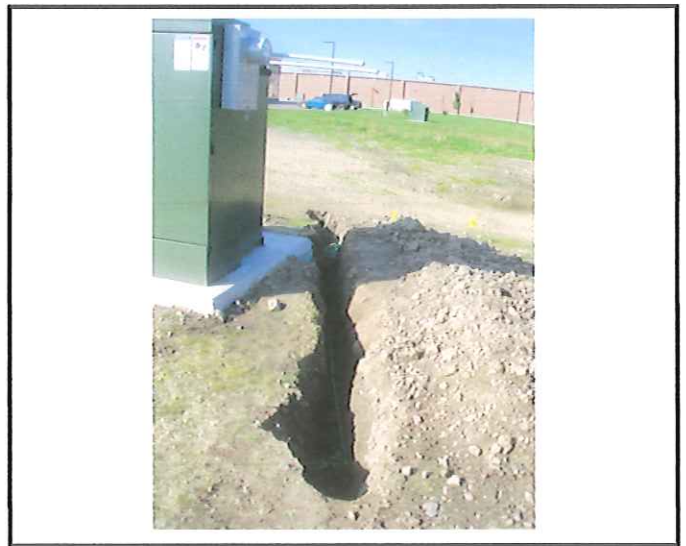
Trench open still.
